Storm Sewer
Daylight point
(Lubber Run)
Inspection with photos
by ECC on 4/4/13

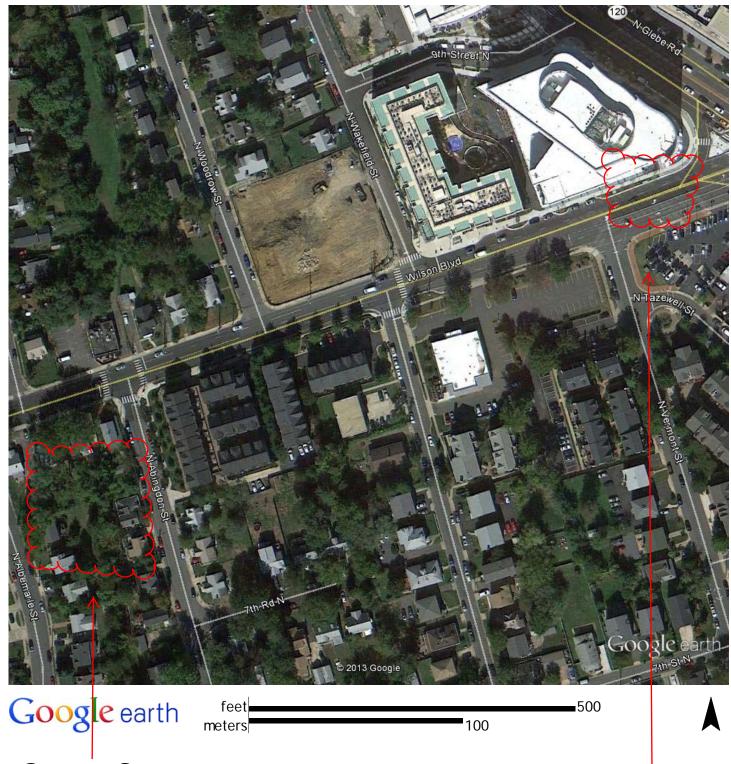
Approx location of SWM Vault #4
